CASE STUDY

UNDER HOUSE SEEPAGE FLOODING

Location: Paddington, Brisbane

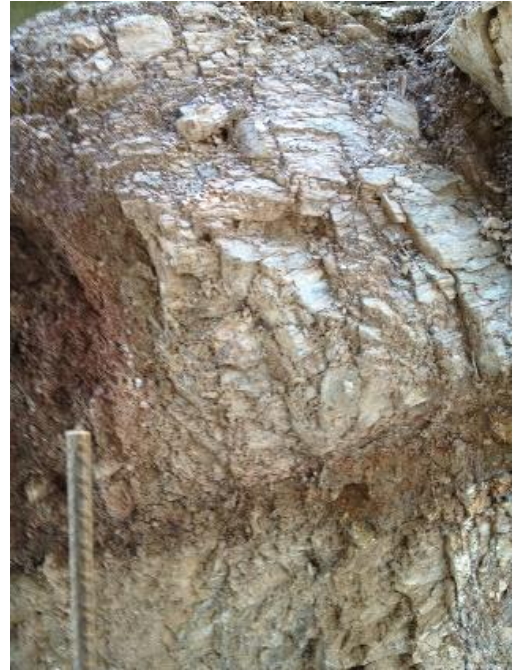
Note the fractured rock strata through groundwater runs freely.

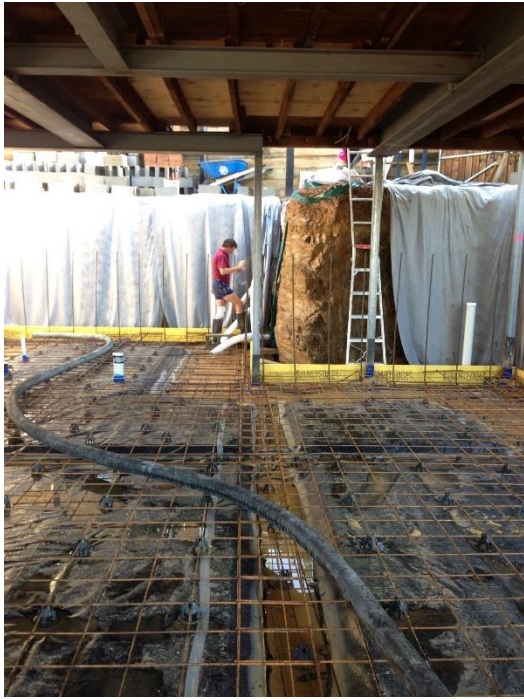
The slab ready for pouring. Note that the Capiphon has been covered with more coarse sand and plastic sheeting before the reinforcing has been laid.

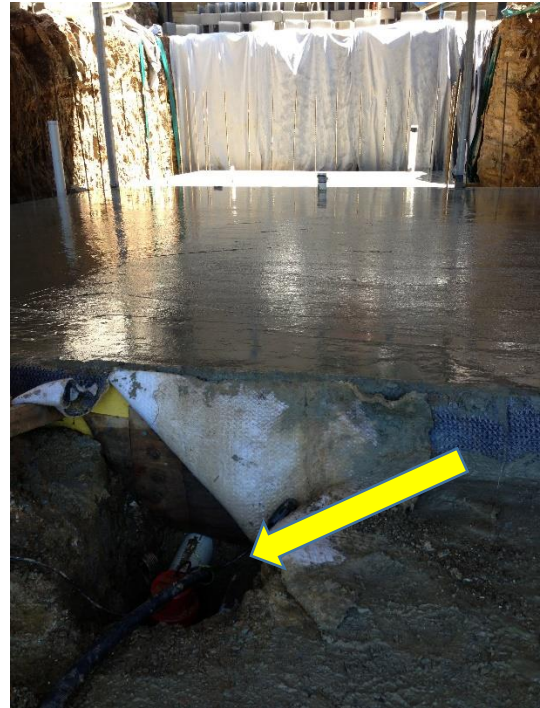
The slab immediately after pouring. Note the discharge pipe (arrow) exiting from under the slab.

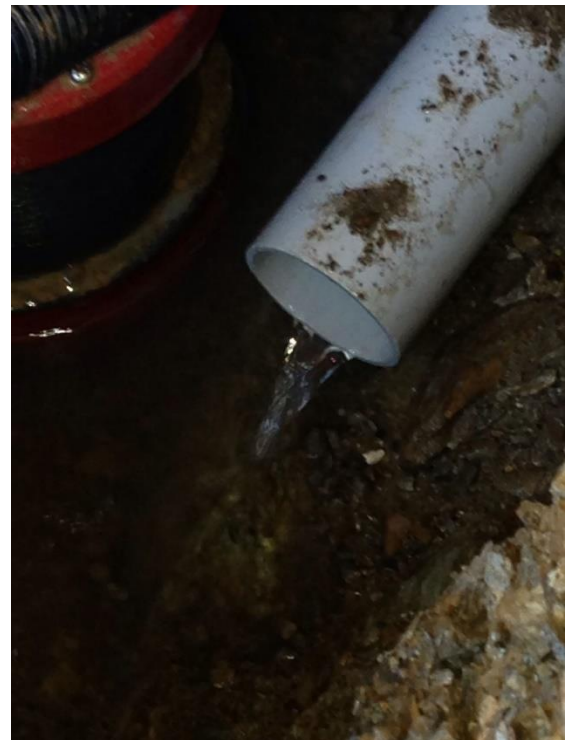
Discharge from the pipe under the slab, some 3-4 days after the slab had been poured. Note that there had been significant rain before the slab was laid but none since. Click on the image for video.
